PICKING UP THE PIECES

Utilizing DISASTER RECOVERY PROJECT MANAGEMENT
to improve readiness and response time.

BY PHILLIP E. HAYES & AUBREY HAMMONS

IEEE INDUSTRY APPLICATIONS MAGAZINE • NOV | DEC 2002 • WWW.IEEE.ORG/IAS

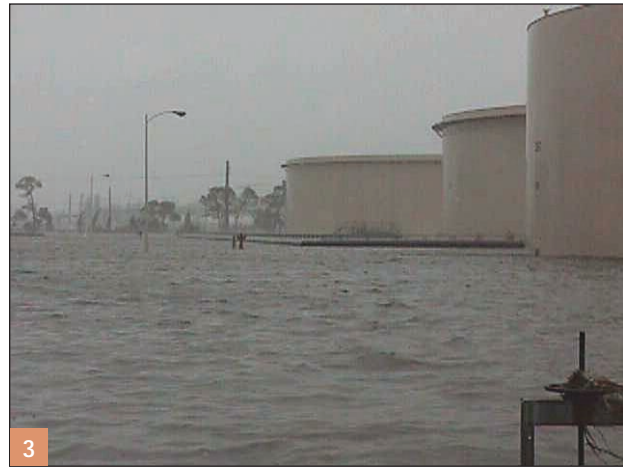
The 12-ft storm surge quickly overcame the refinery's 9-ft levies, flooding the facility in up to 5 ft of seawater in the office building, units, and tank farm alike.

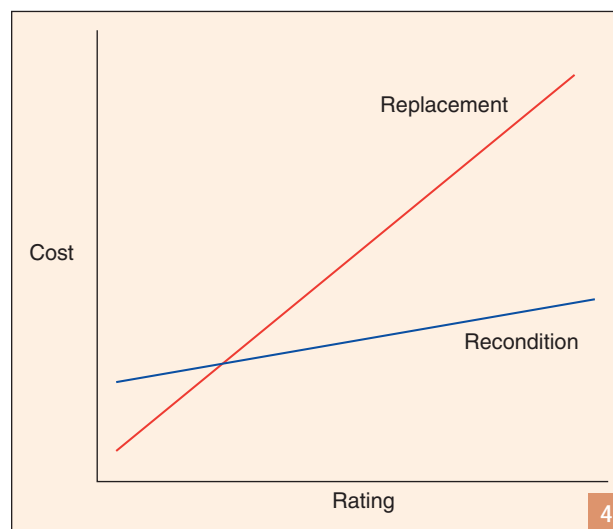
The relationship between the cost of reconditioning electric motors versus replacing them.

The first step was to determine replace versus recondition guidelines. Refinery reliability engineering worked with the insurance companies to determine the lines of demarcation with input from the business partner. Typical reconditioning requirements were defined and the cost of these repairs estimated for a range of ratings. Recondition costs were compared to the replacement cost for standard off-the-shelf equipment. See Fig. 4 for a representation of the basic relationship between the cost of reconditioning versus replacement.
